Geotechnical Extreme Events Reconnaissance
Turning Disaster into Knowledge

Soil Liquefaction in the Christchurch Area during Recent Earthquakes

Jonathan D. Bray, Ph.D., P.E.
University of California, Berkeley

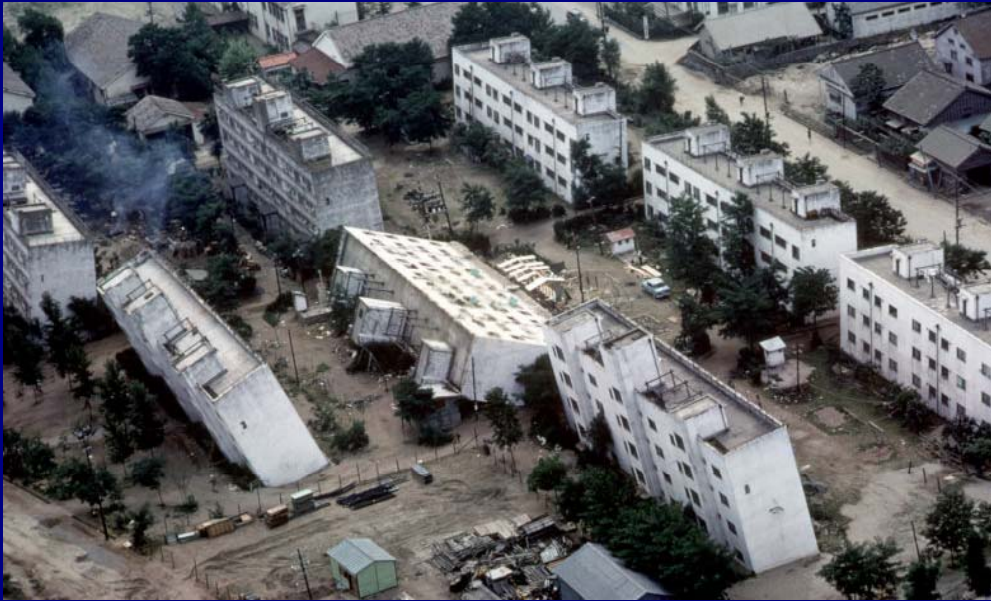
1964 Niigata, Japan EQ (from H.B. Seed)

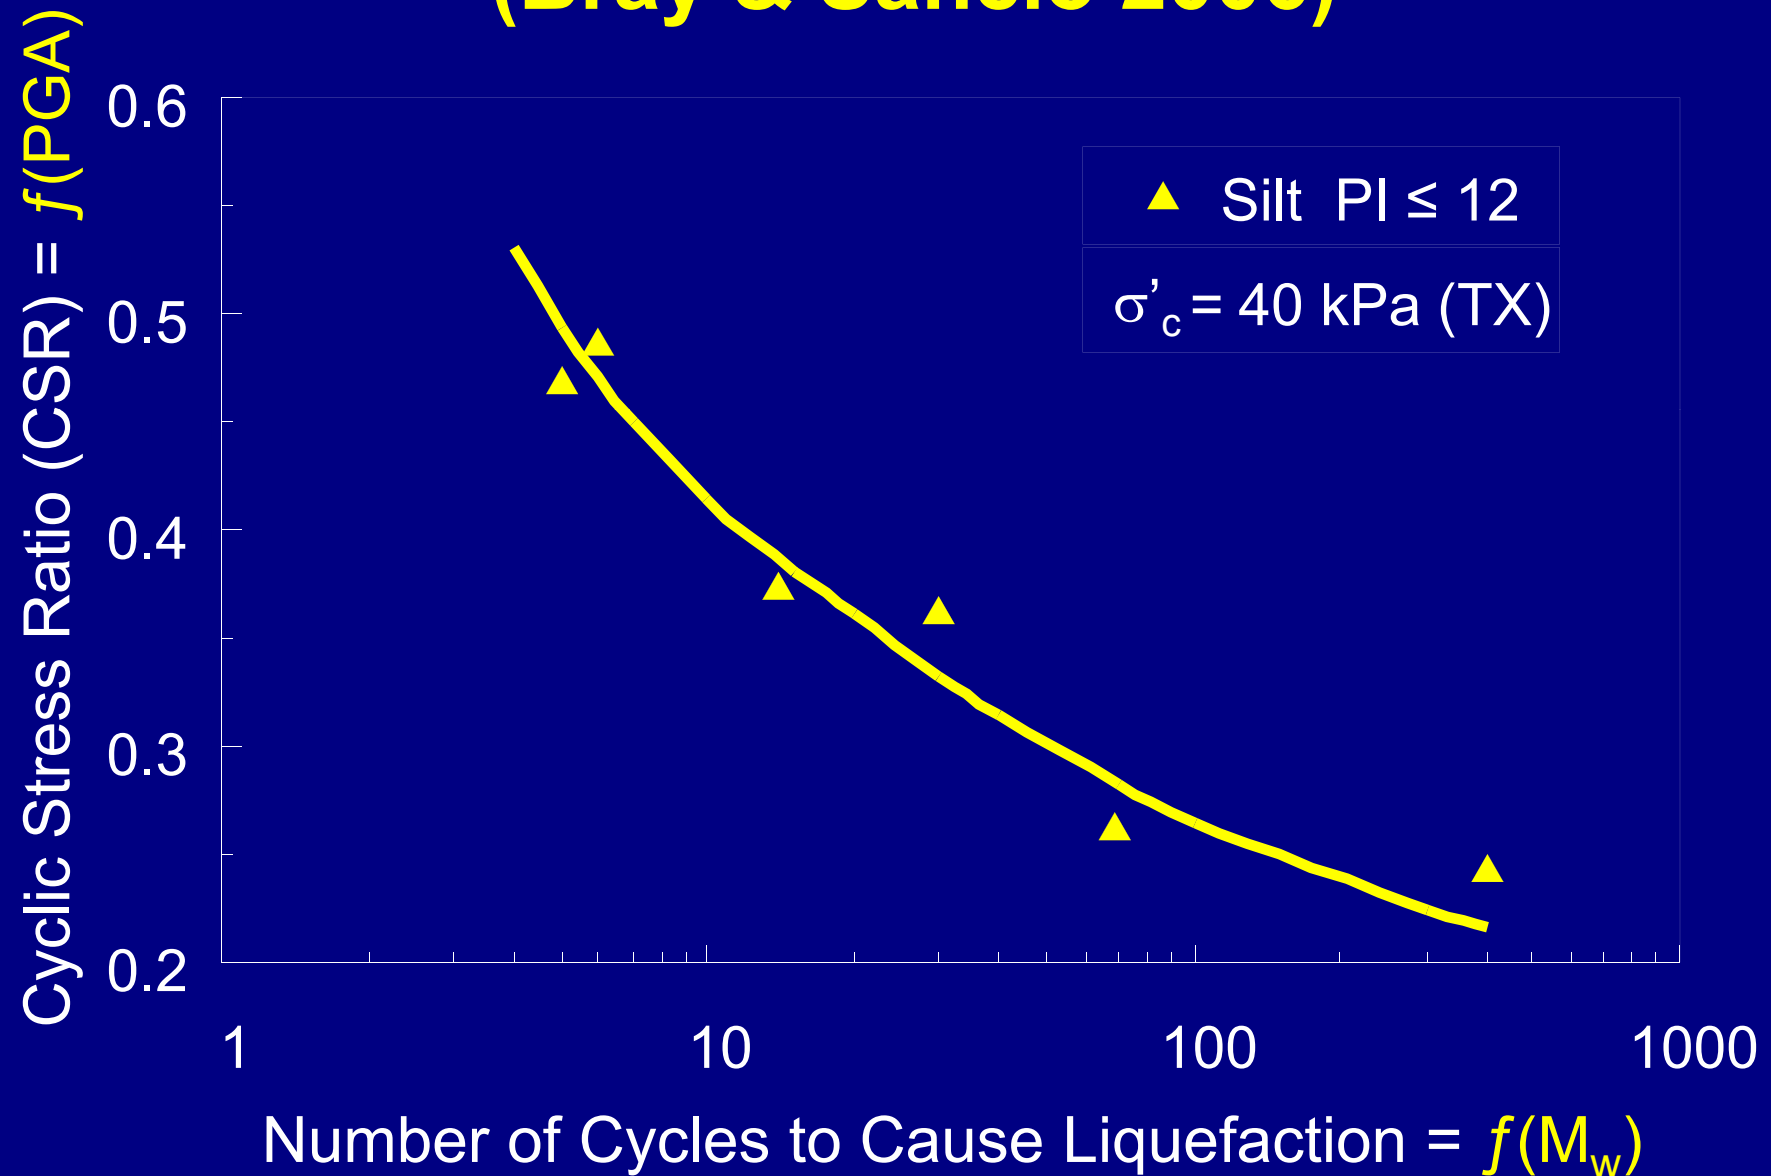
Liquefaction Testing on Adapazari Silt (Bray & Sancio 2006)

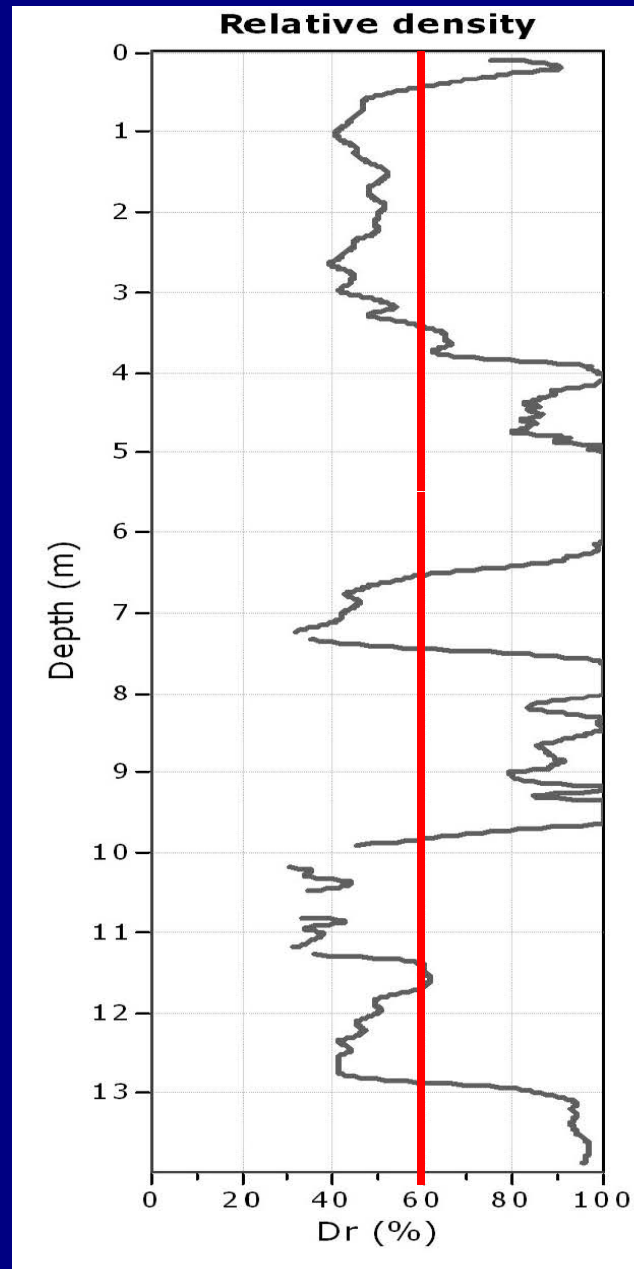
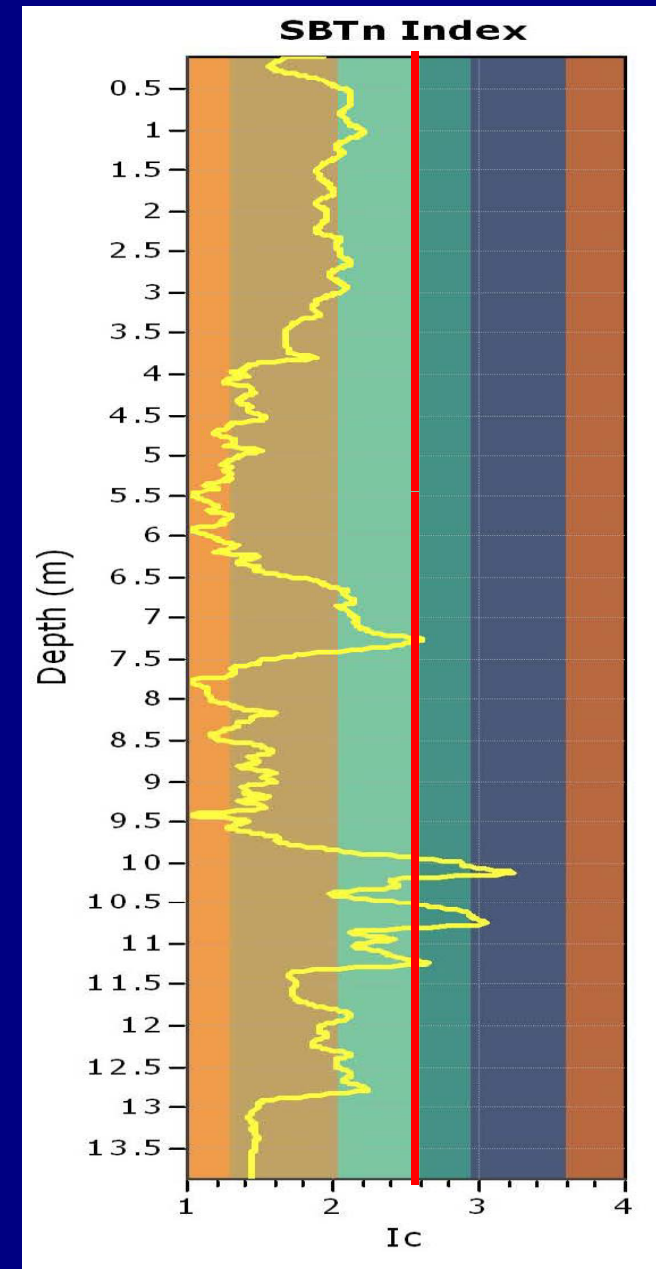
Subsurface Profile at Madras & Armagh Sts.

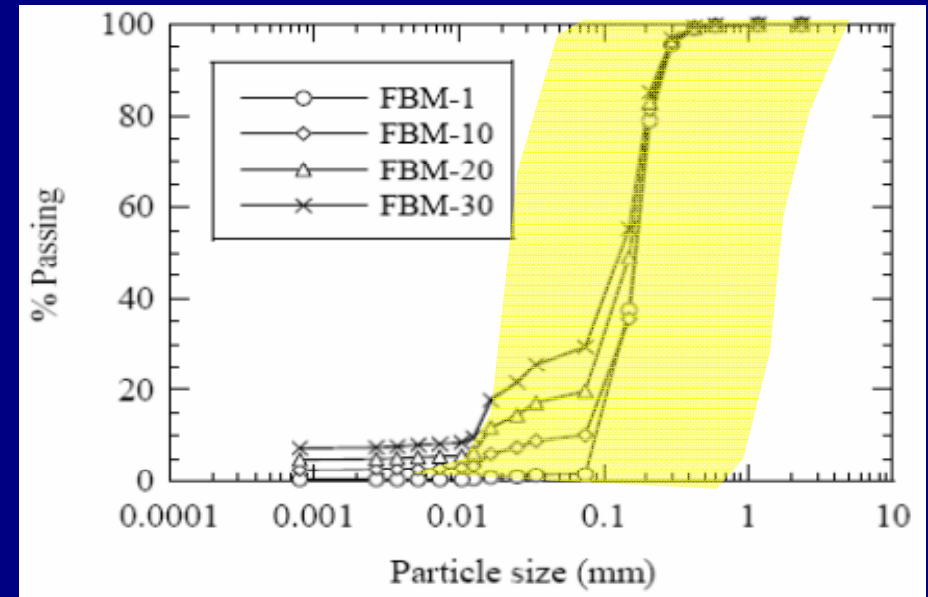
Fitzgerald Bridge samples

- Clean sands and non-plastic silty sands
- Soils are susceptible to liquefaction

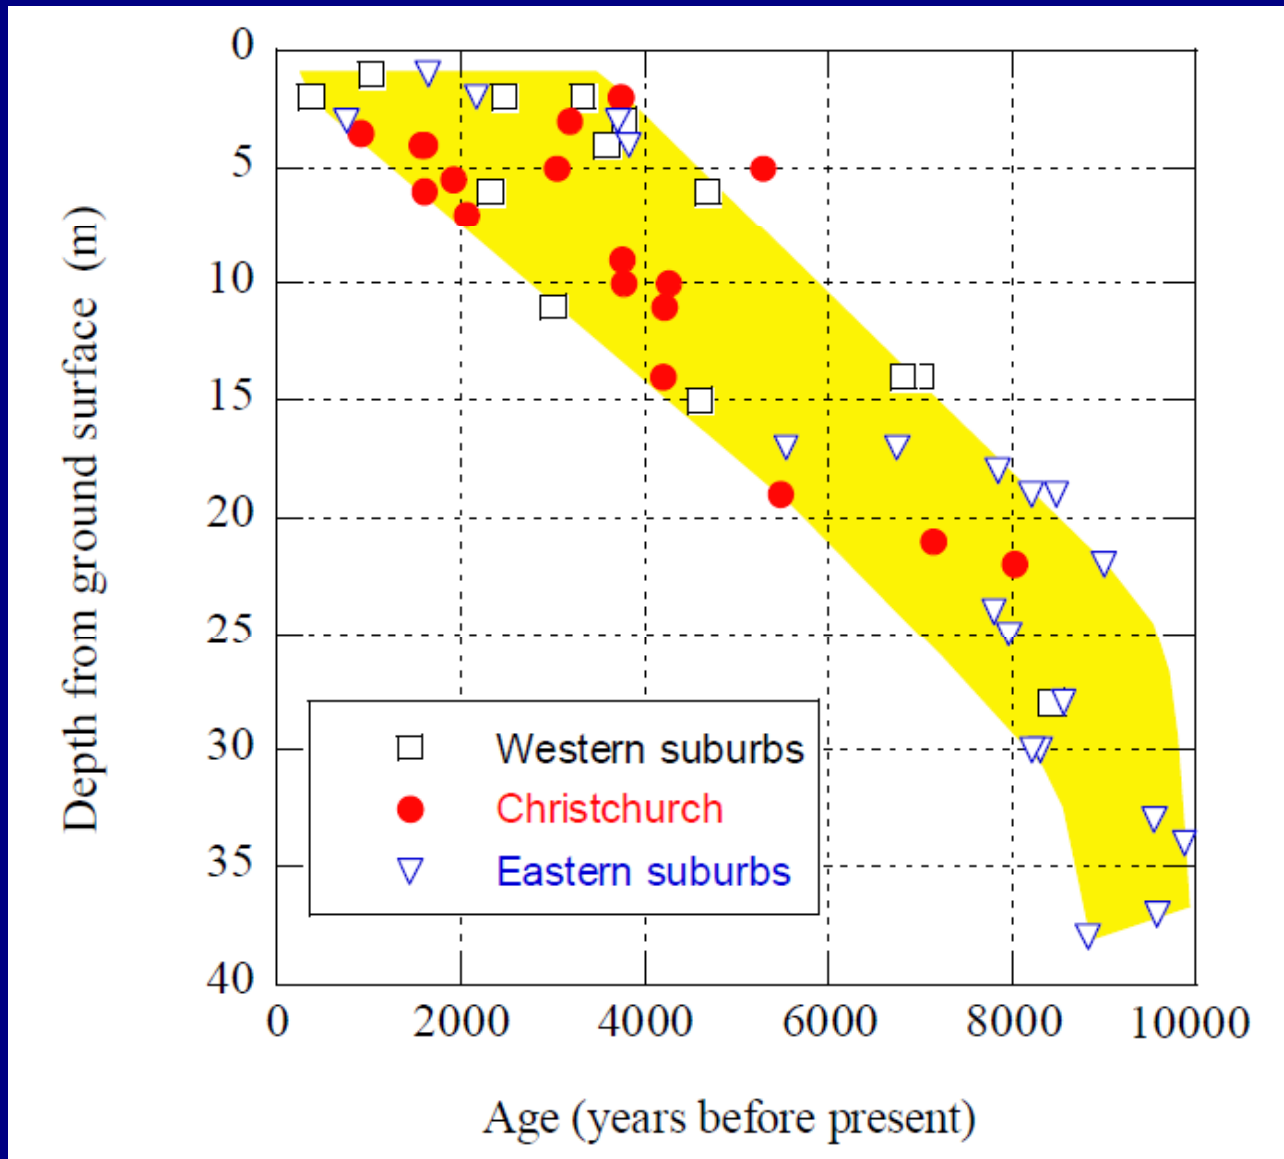
Age of Christchurch Soils

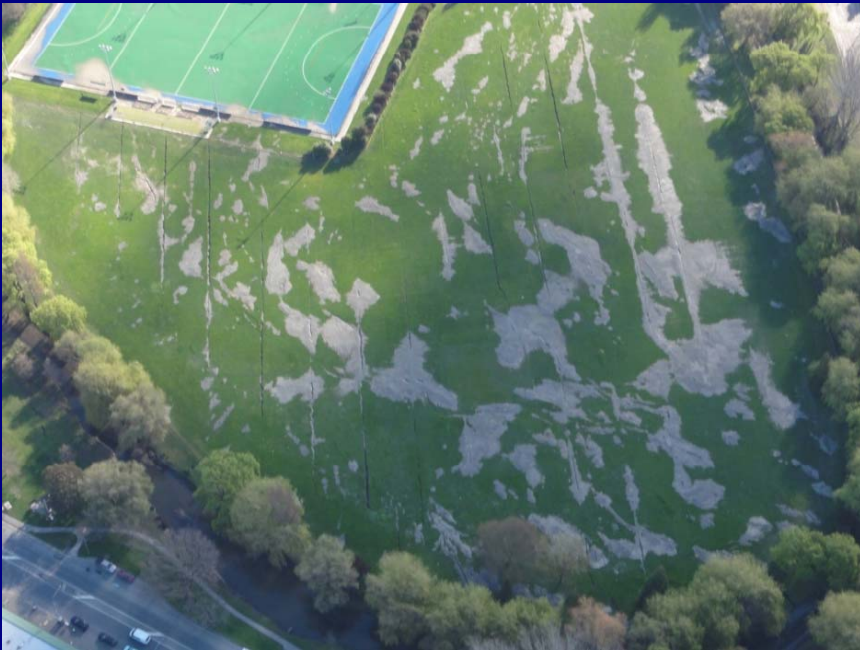
Liquefaction at Porritt Park

4 Sep 2010 EQ - $CSR_{M7.5} = 0.11$

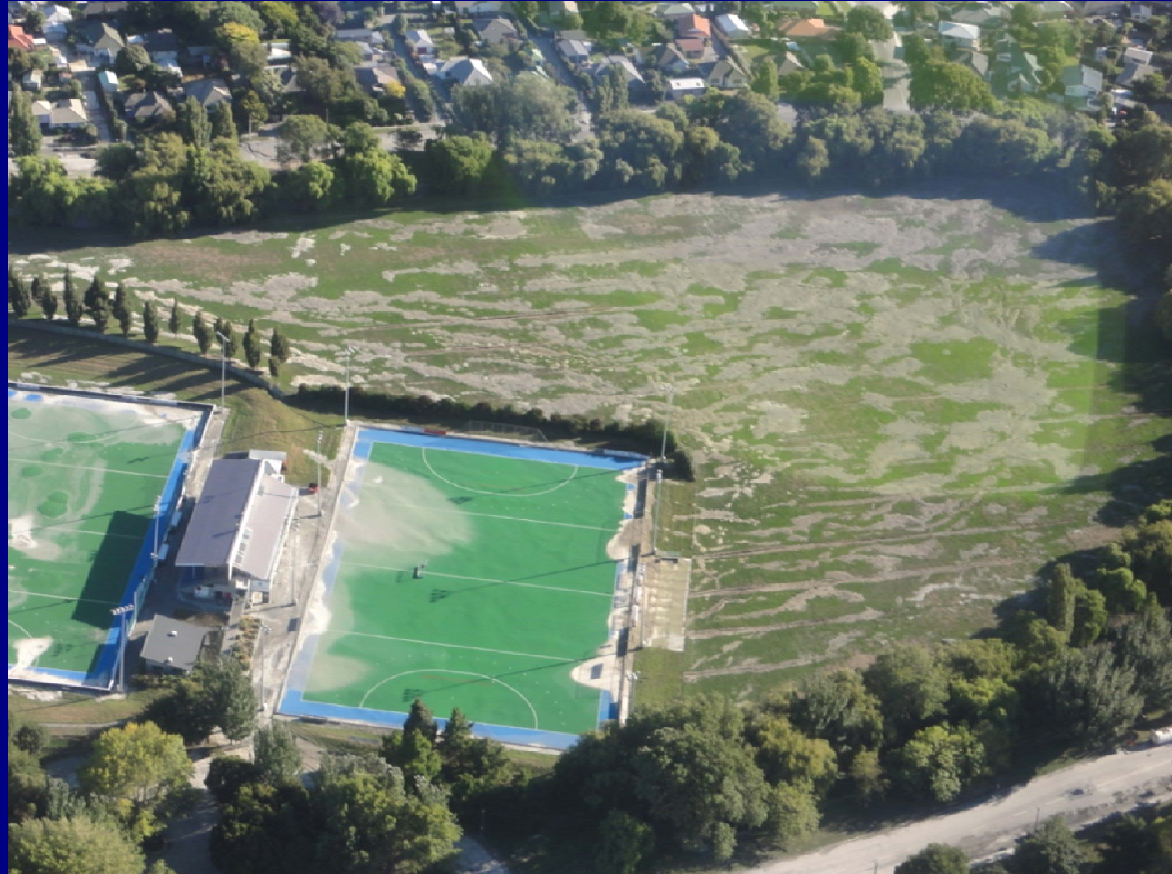
22 Feb 2011 EQ - $CSR_{M7.5} = 0.18$

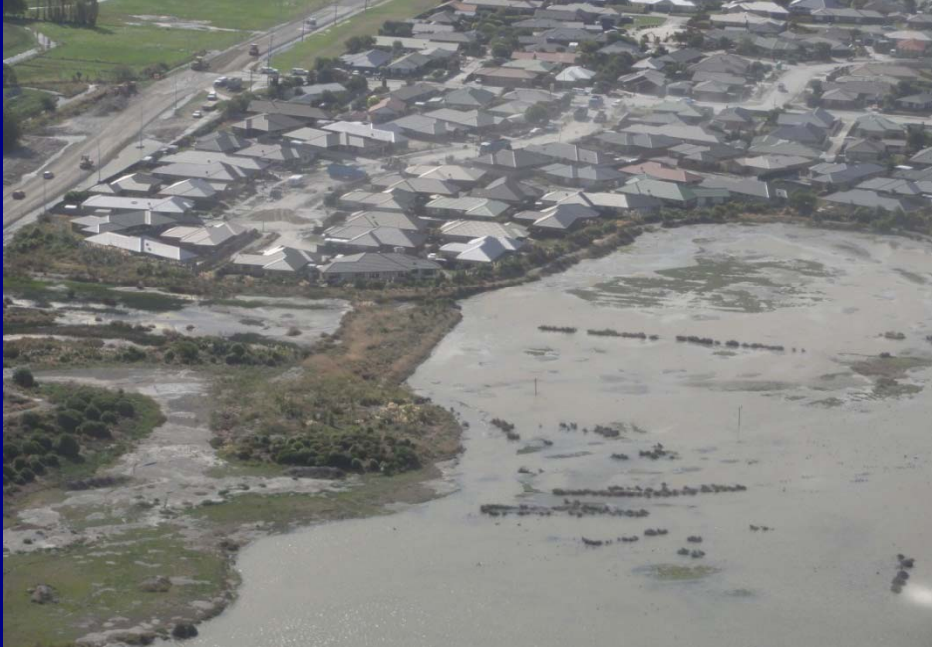
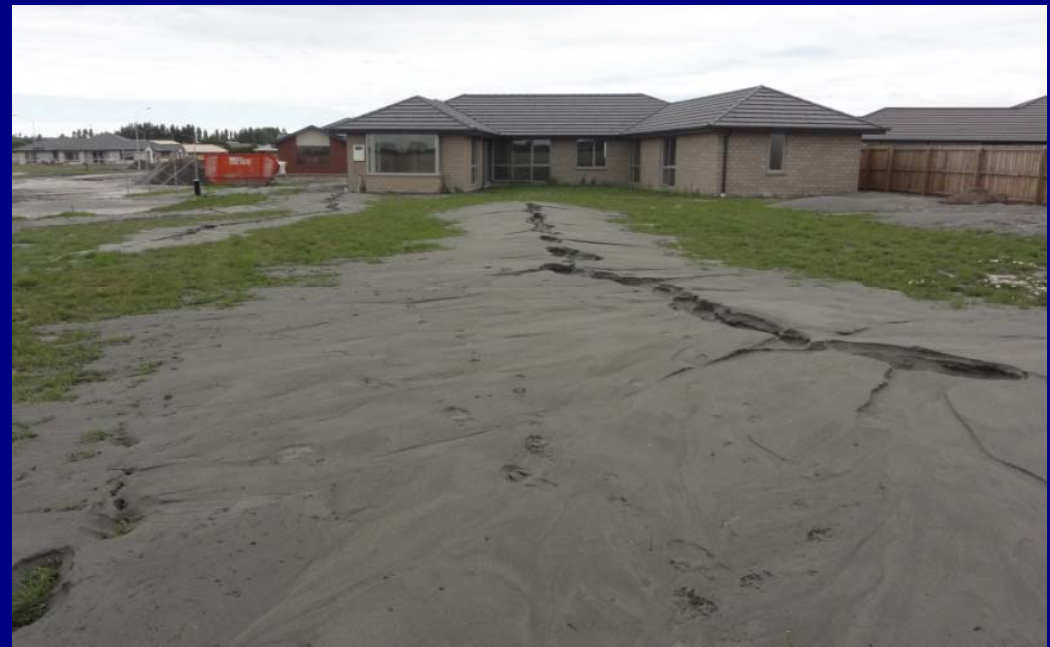
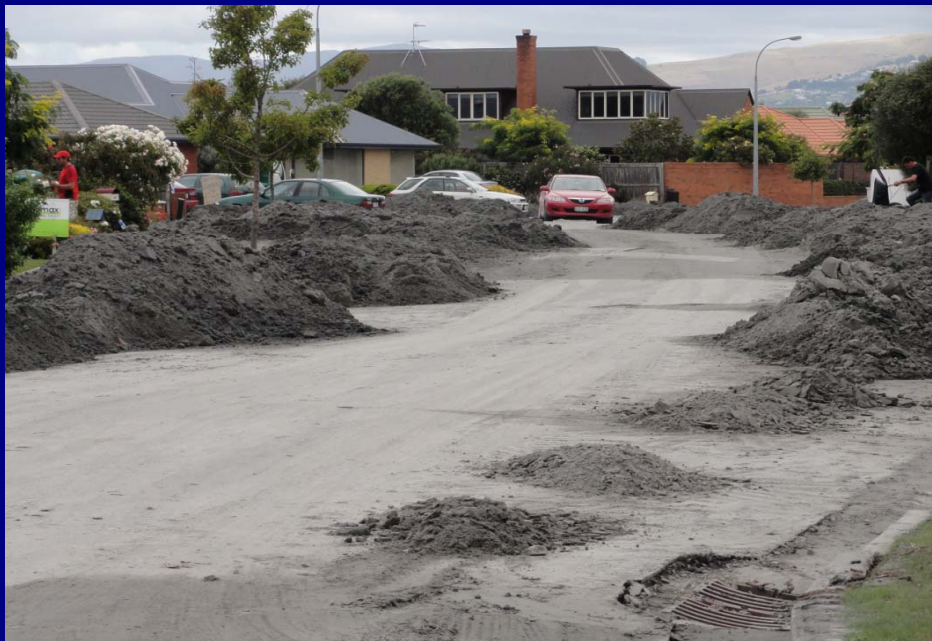
Severe Liquefaction in Suburbs

- Large areas covered by thick sand ejecta
- Large subsidence in some suburbs

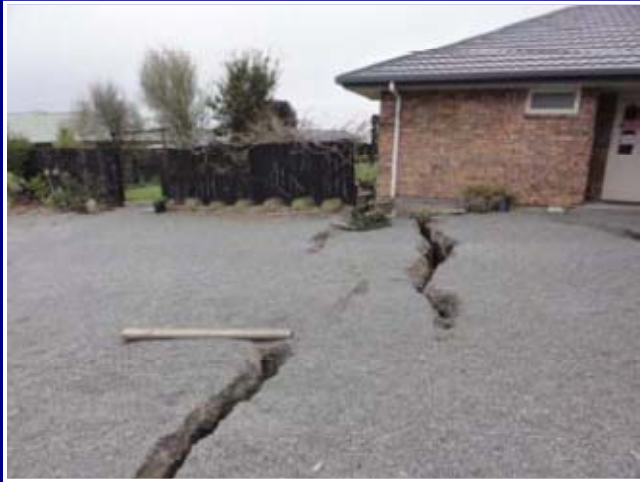
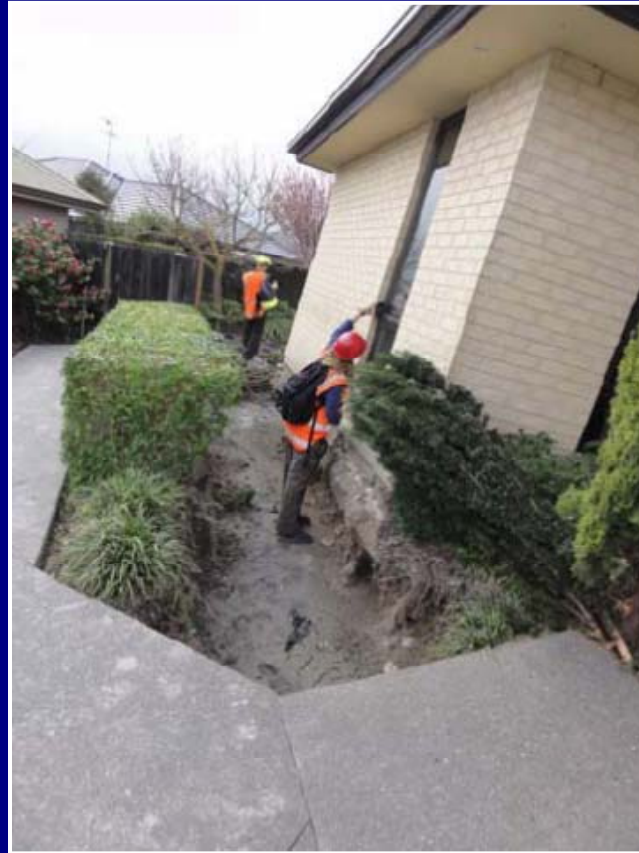
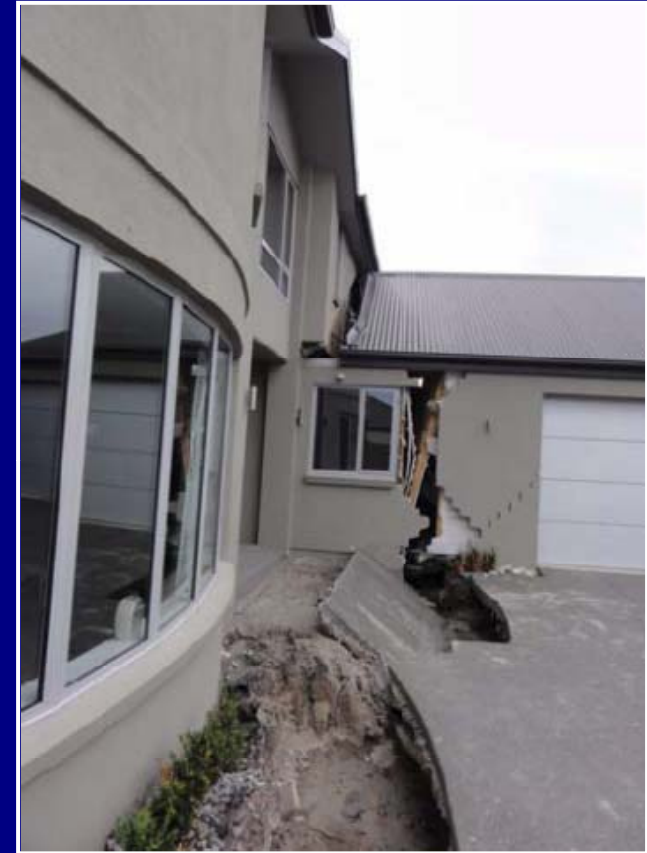
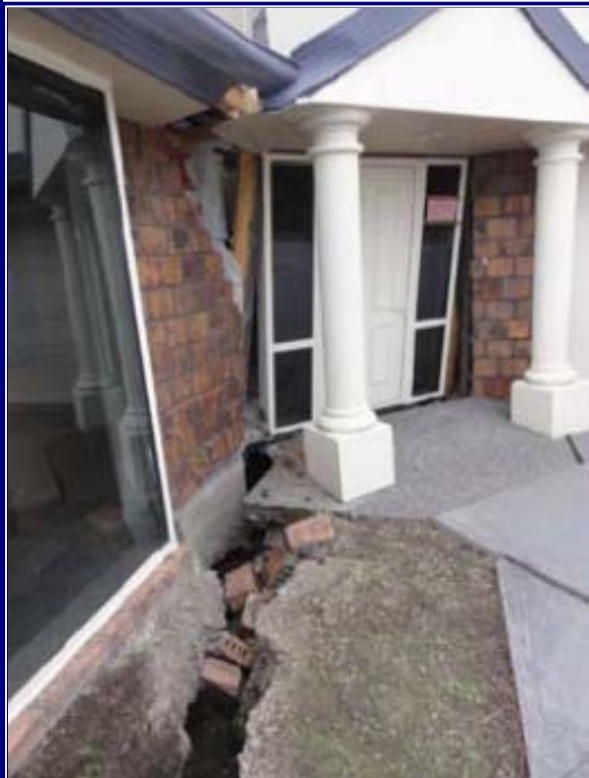
Damage to Residential Buildings

- ~ 1.5 m wide cracks
- Severe damage to foundations & houses

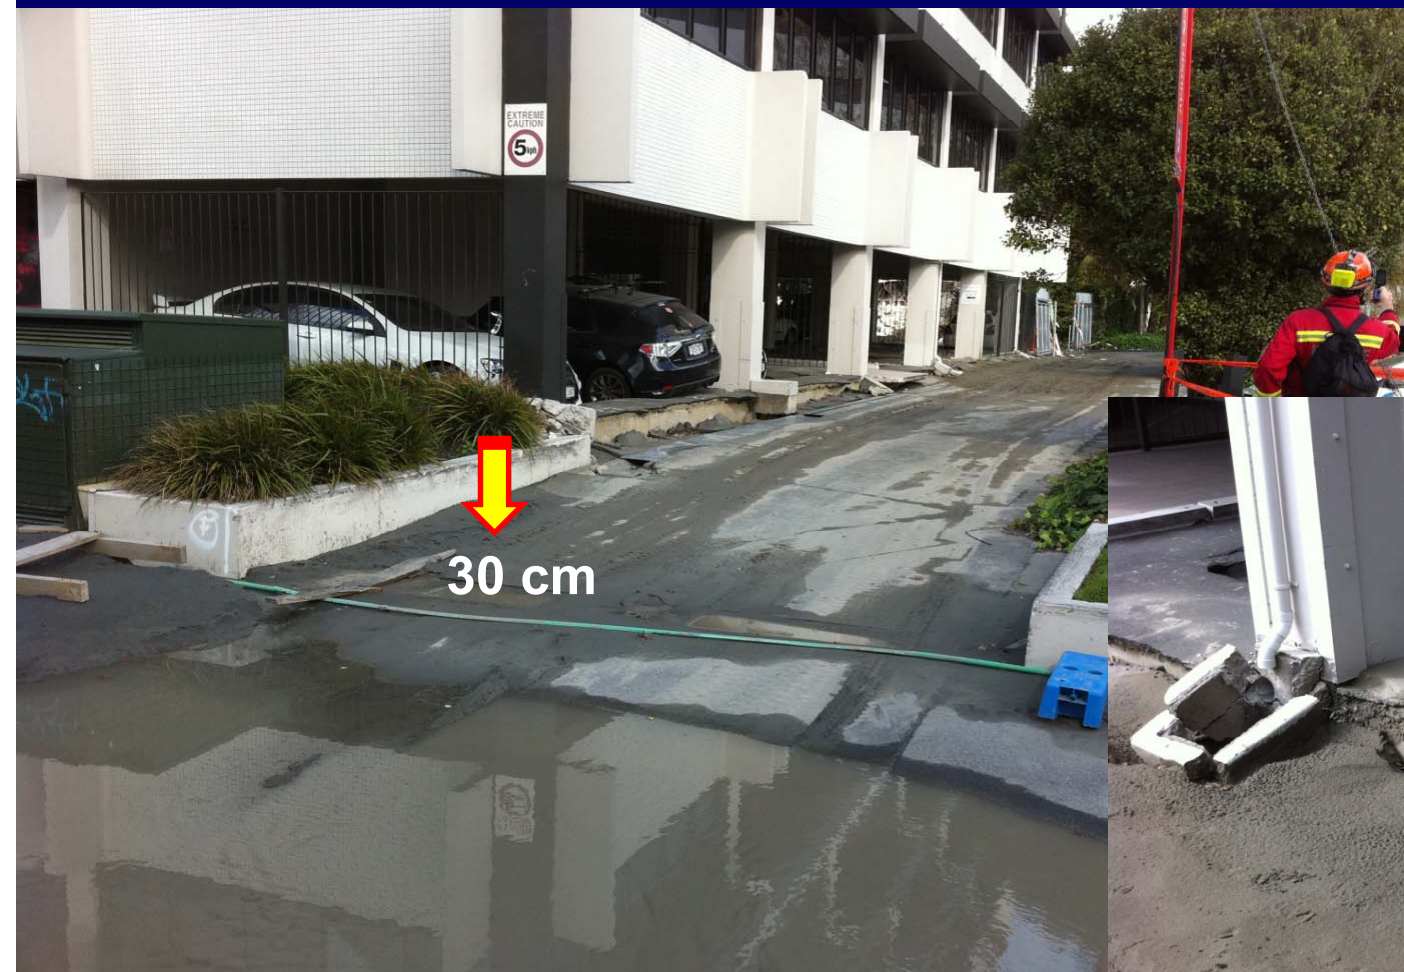
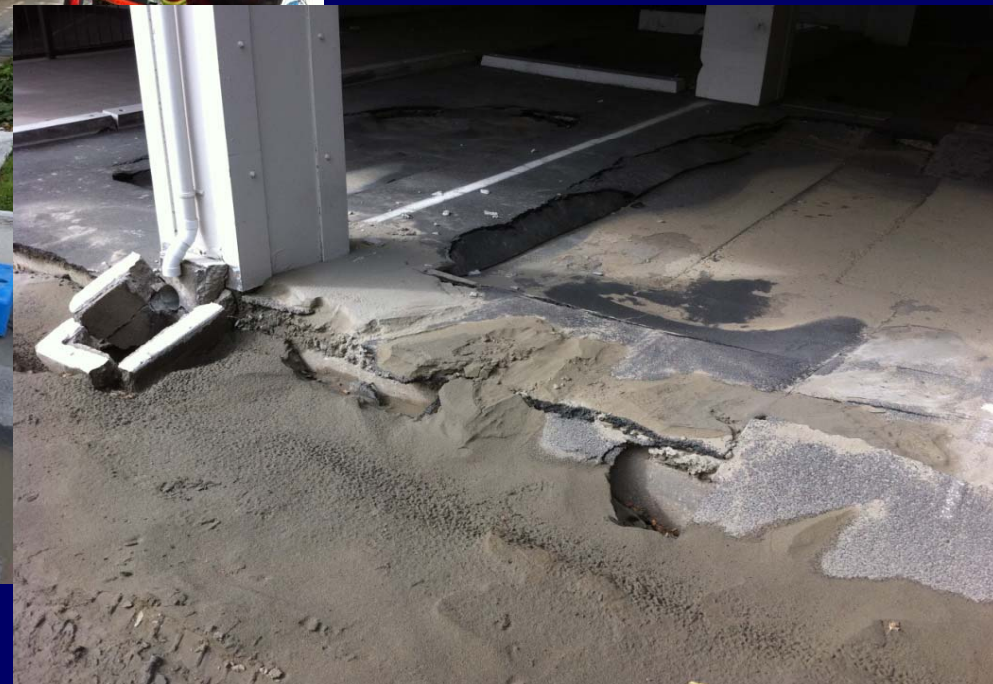
Liquefaction Effects on Buildings in CBD:

Settlement of Ground Adjacent to Pile Supported Foundation

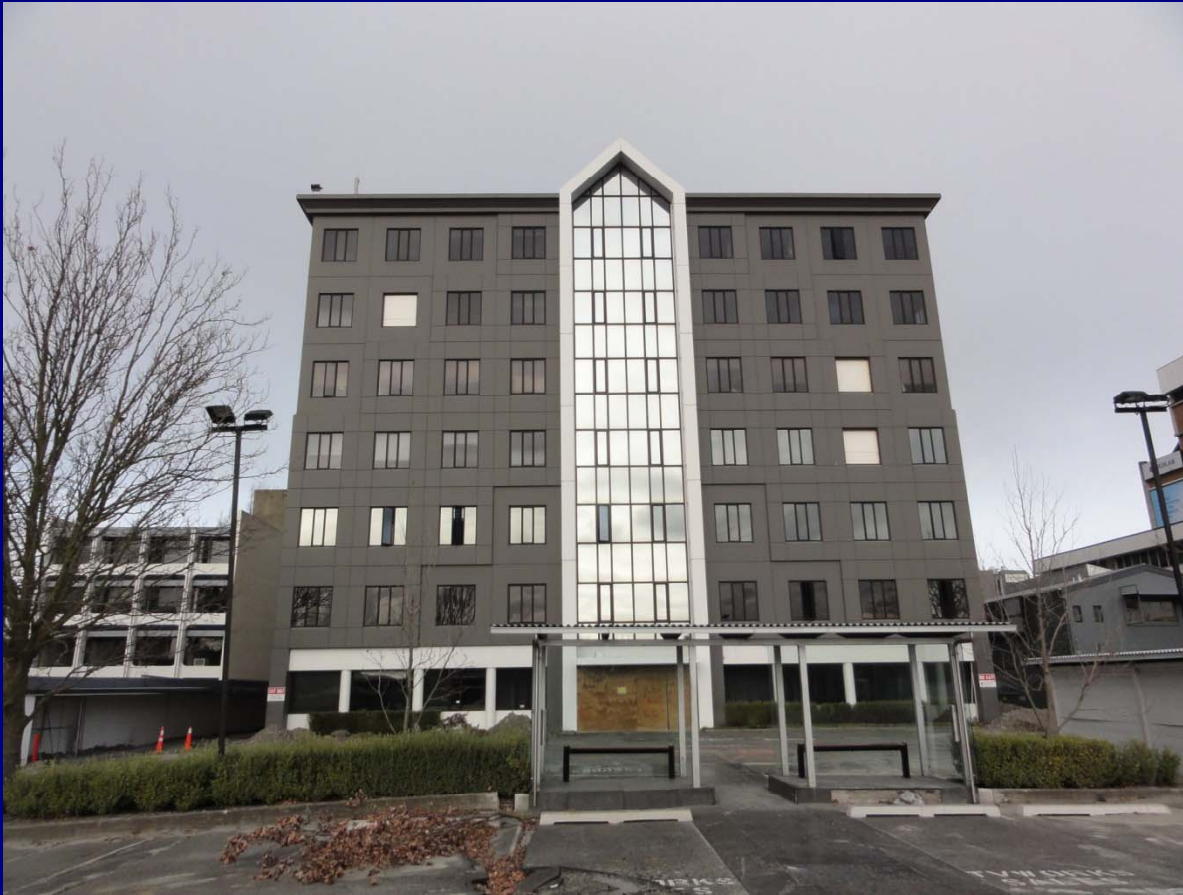
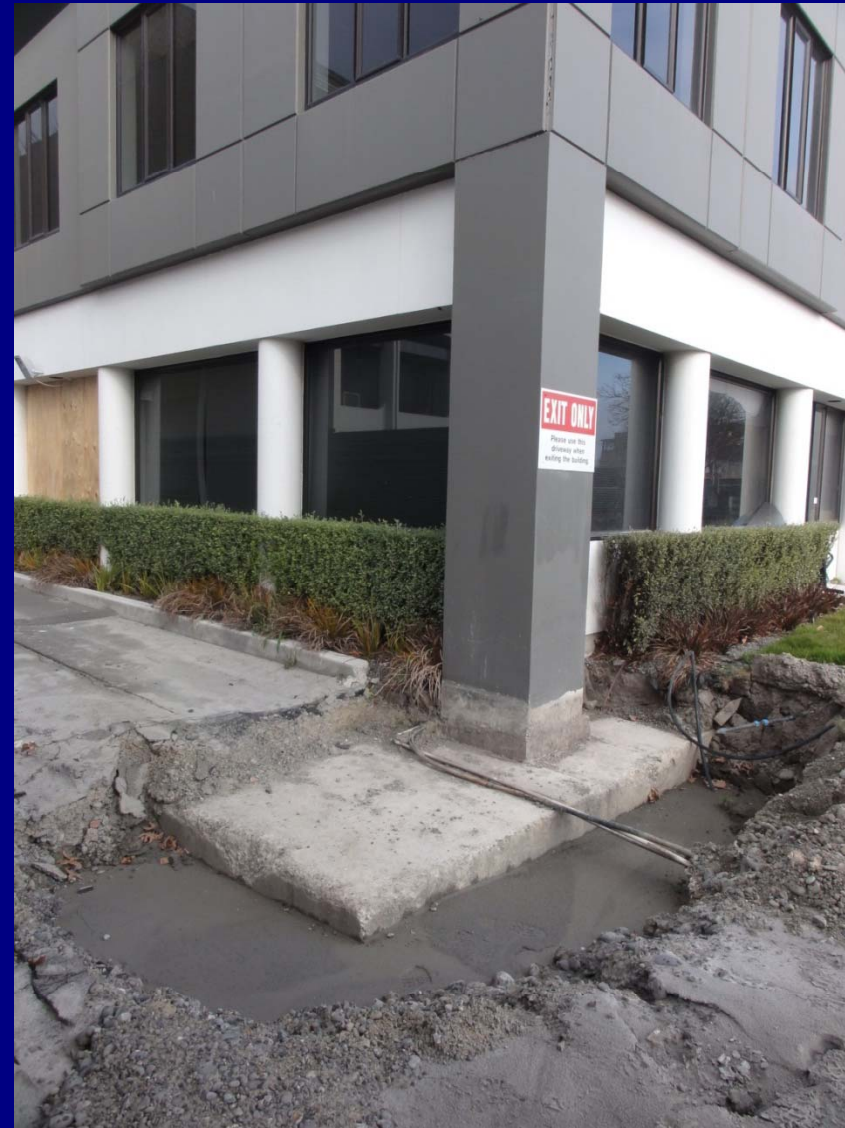
Building on Shallow Foundations

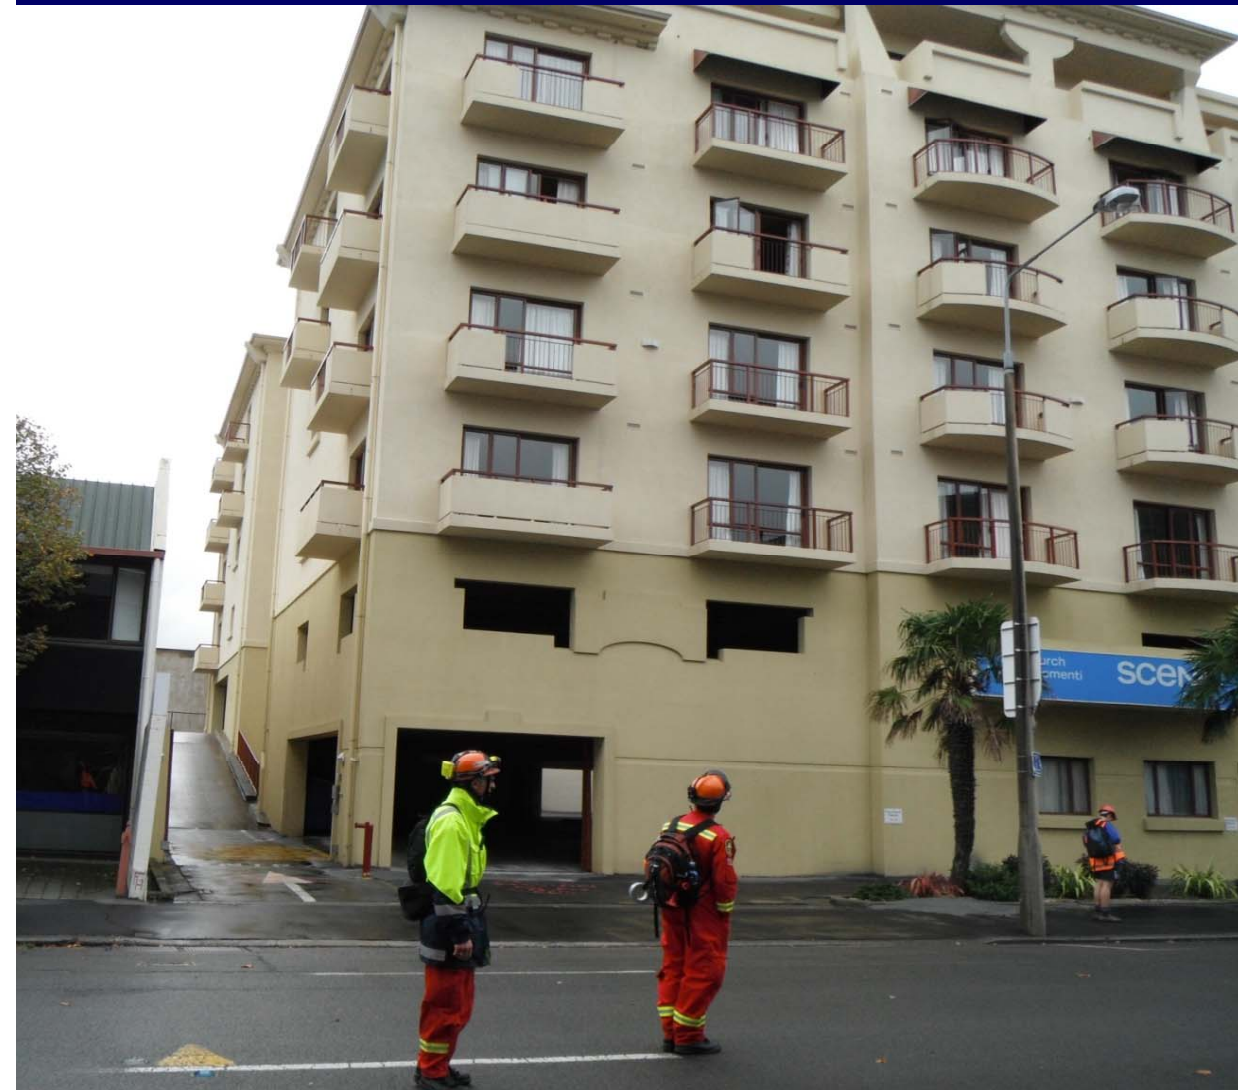
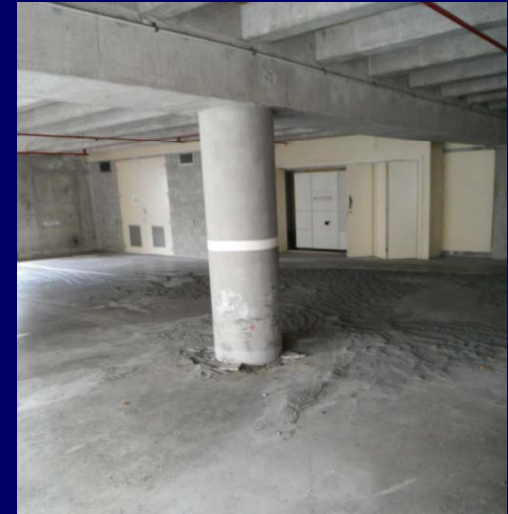
Uniform Settlement of Ground and Building

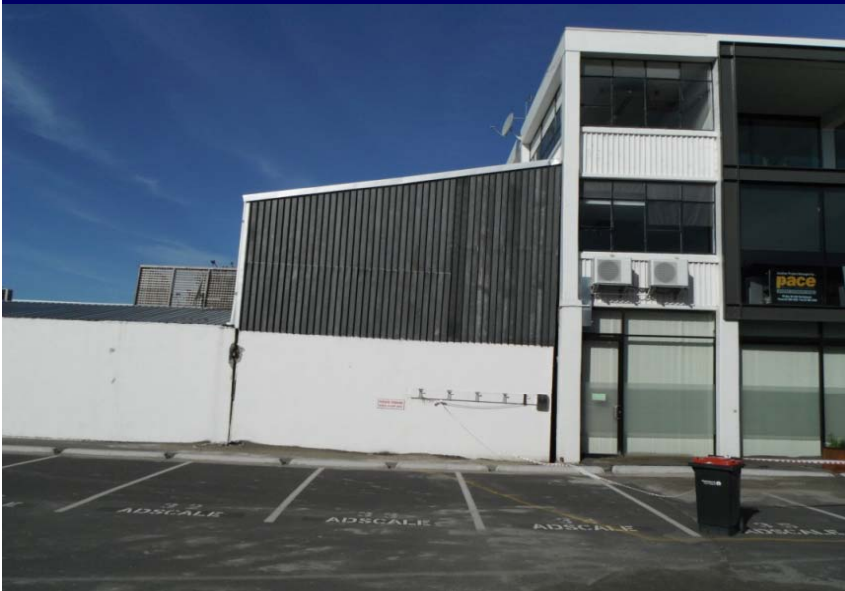
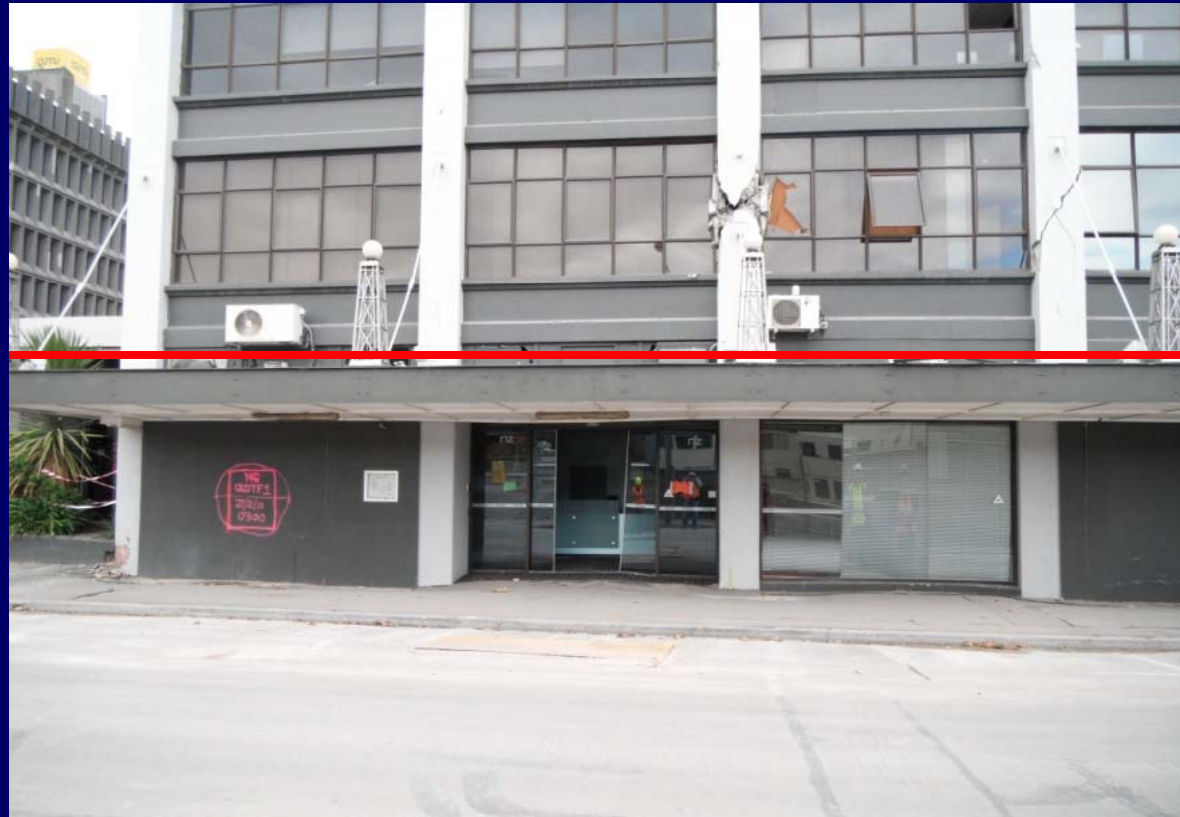
Liquefaction Effects on Buildings: Tilting and Differential Settlement

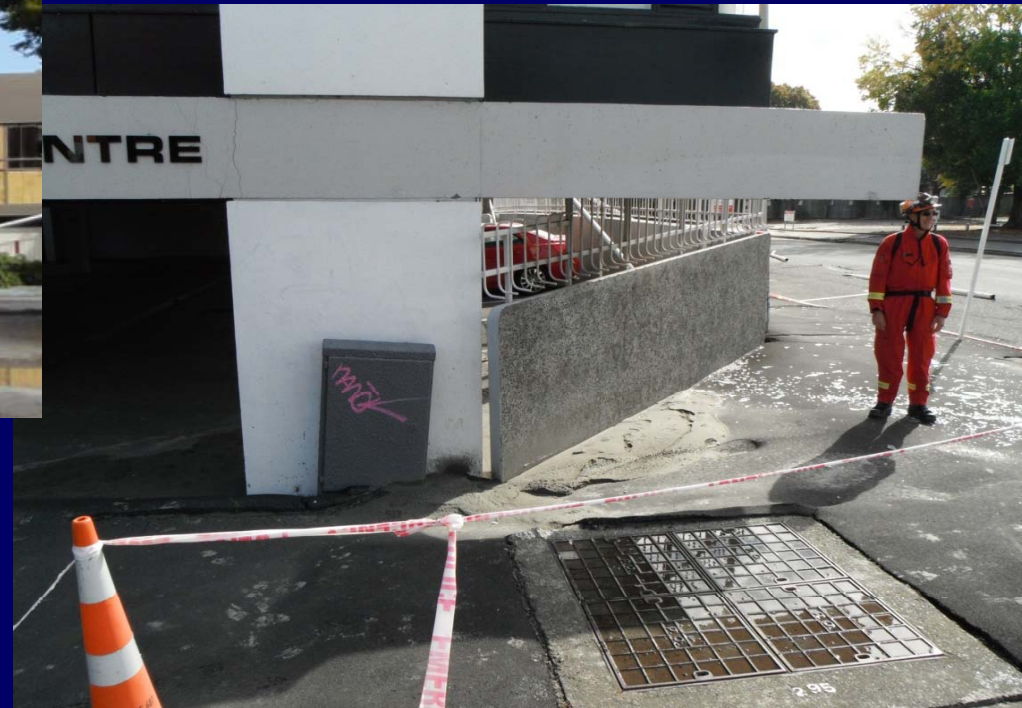
Differential Settlement of Adjacent Columns Induces Distress

Building Settlement (cm)
Maximum Angular Distortion $\approx 1/50$

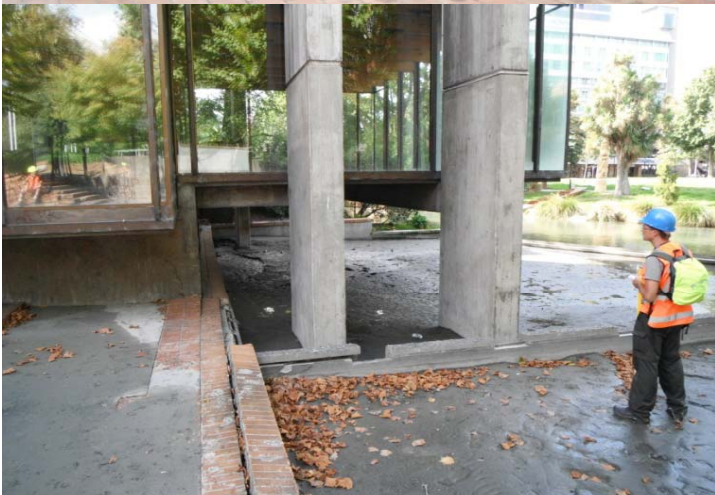
Differential Settlement of Adjacent Columns Induces Distress

Angular distortion of $1/70$

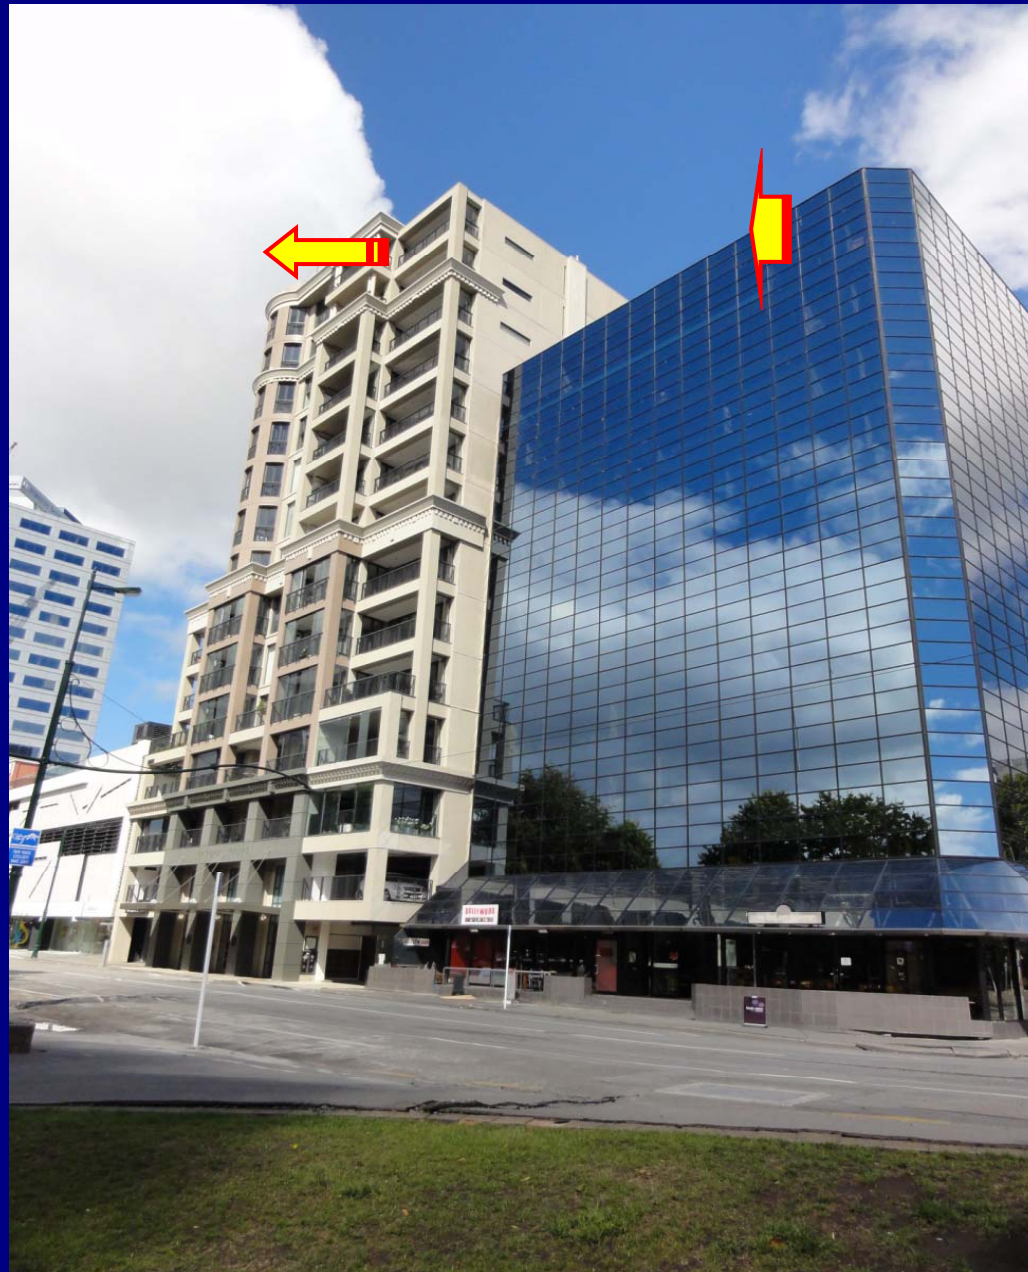
Tilting of Tall Buildings
